Fracture load of metal-ceramic, monolithic, and bi-layered zirconia-based posterior fixed dental prostheses after thermo-mechanical cycling

Objectives: This study aims to evaluate the fracture load of differently fabricated 3-unit posterior fixed dental prostheses (FDPs) with an intermediate pontic.

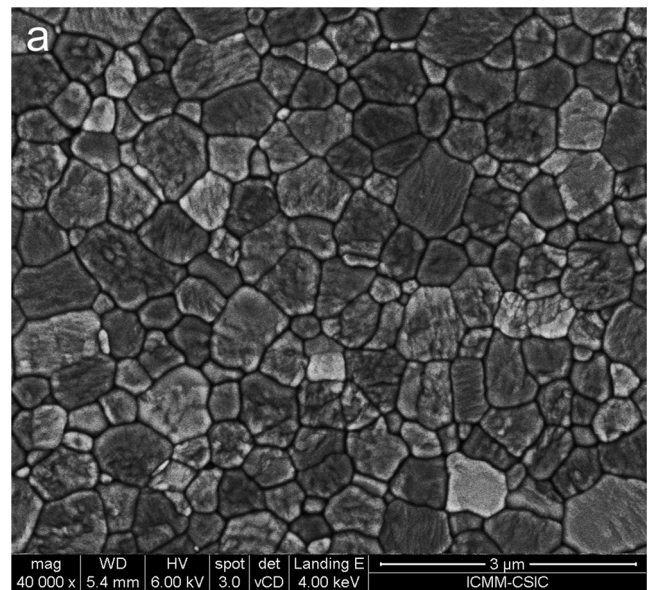
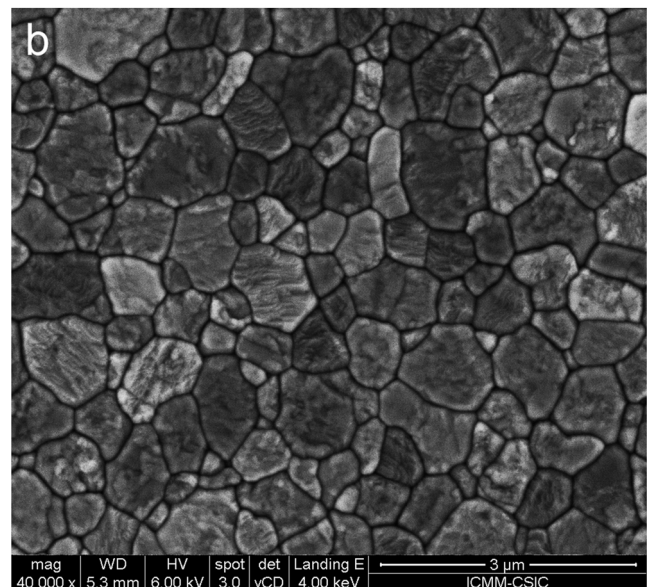
Fig. 1. FEG-SEM images of material characterization (40,000× magnifications; WD: 5.4 mm; HV: 6.00 kV; spot: 3.0; det: vCD; landing E: 4.00 keV; bar: 3 μm). (a) LM specimen showing small grains. (b) LZ sample containing bigger grains than did LM pieces.

Prior to the mechanical test, the microstructure was analysed on flat-parallel 1.8 mm-thick samples ($n = 10$ per zirconia group) that were cut from pre-sintered CAD/CAM blocks in a metallographic micro-cutting machine (Micromet; Remet, Bologna, Italy) with a diamond disk under irrigation. The specimens were sintered and veneered according to the manufacturers' specifications. The final pieces were embedded in epoxy resin and polished to 1 μm in an automatic device (Phoenix Beta; Buehler) by using different diamond suspensions. Finally, samples were thermal-etched at 1300 °C for 30 min. The specimens were then examined under Field emission gun scanning electron microscope (FEG-SEM, Nova NanoSEM 230; FEI, Eindhoven, Holland) at 40,000 \times magnifications. The average grain size was determined by applying the line intersection method to the representative FEG-SEM images of each group (ASTM E112-96(2004)e2 linear intercept count method) [37,38].

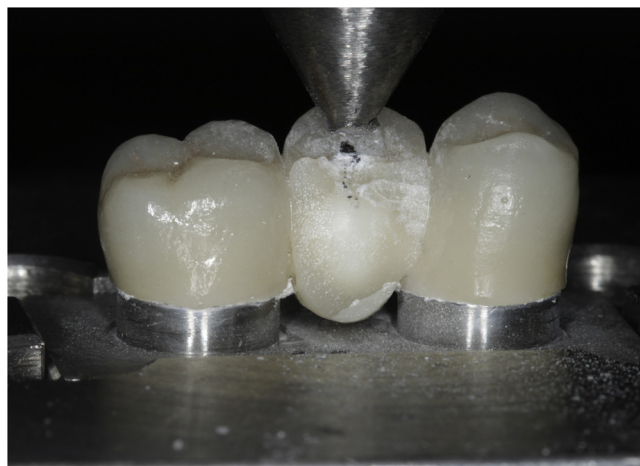
Fig. 2. ZZ restoration showing delamination of the veneering ceramic at the buccal surface of the intermediate pontic. A stepped and rough topography is discovered.

In the bi-layered groups (MC, LZ, YZ, and ZZ), the veneering porcelain always failed before the total breakage of the specimens resulting in delamination of the ceramic coating except for the YZ group, in which three FDPs (30%) showed no previous veneering fracture. An irregular surface was discovered where the veneering material detached from the cores, with porcelain still bonded to the structures in all cases (Fig. 2).

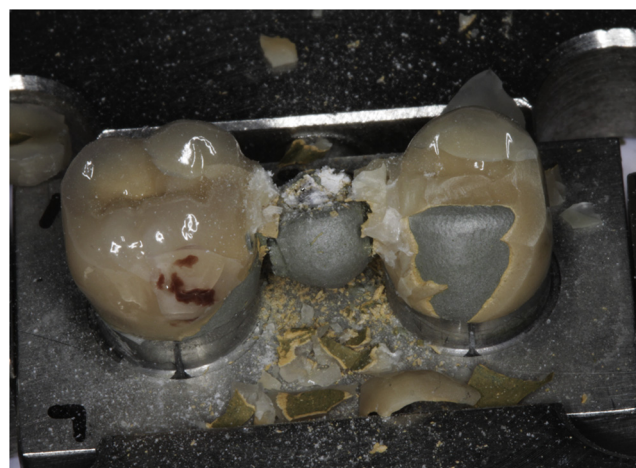
Fig. 3. Ductile fracture of a MC sample (at the connector). The plastic deformation impedes the exact fitting of the broken parts along the fracture line.

A ductile failure starting at the occlusal aspect of the connectors was identified in all of the MC samples (Table 2) such that the higher the plastic deformation at the ultimate load, the rougher the fracture margins. Owing to the jagged topography of the broken frameworks, the fragments of MC samples could not be completely repositioned

(Fig. 3).

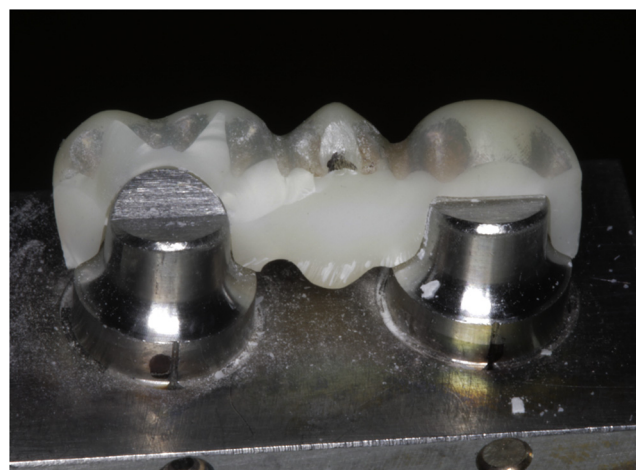
Fig. 4. LM piece fractured in half, lengthwise. The flat broken surface reveals a brittle failure.

Conversely, all of the zirconia specimens showed a brittle failure (Table 2), in which the fragments perfectly fitted to each other along the fracture line (Fig. 4). The breakage of LZ, YZ, and ZZ pieces mainly (90%) started at the cervical aspect of the connectors and was diagonally propagated toward the occlusal surface of the pontic through the loading point. In the remaining 10% of cases, the fracture arose at the axial and occlusal surfaces of the retainers. Unlike what happened in the control group, the total failure of LZ, YZ and ZZ restorations occurred quickly after the initial fracture.

Finally, all of the LM monolithic restorations exhibited brittle vertical fractures (Table 2). In this group, the cracks originating within the occlusal surface of the FDPs instantaneously entered the complete thickness of the prostheses in a catastrophic manner. Hence, all of these specimens were broken in half, lengthwise (Fig. 4).
